# South Pond – History and Investigative Summary, Occidental Chemical Company Plant Site, Ludington, Michigan

PREPARED FOR: Denny Huggard/The Dow Chemical Company

PREPARED BY: CH2M HILL

DATE: May 8, 2014

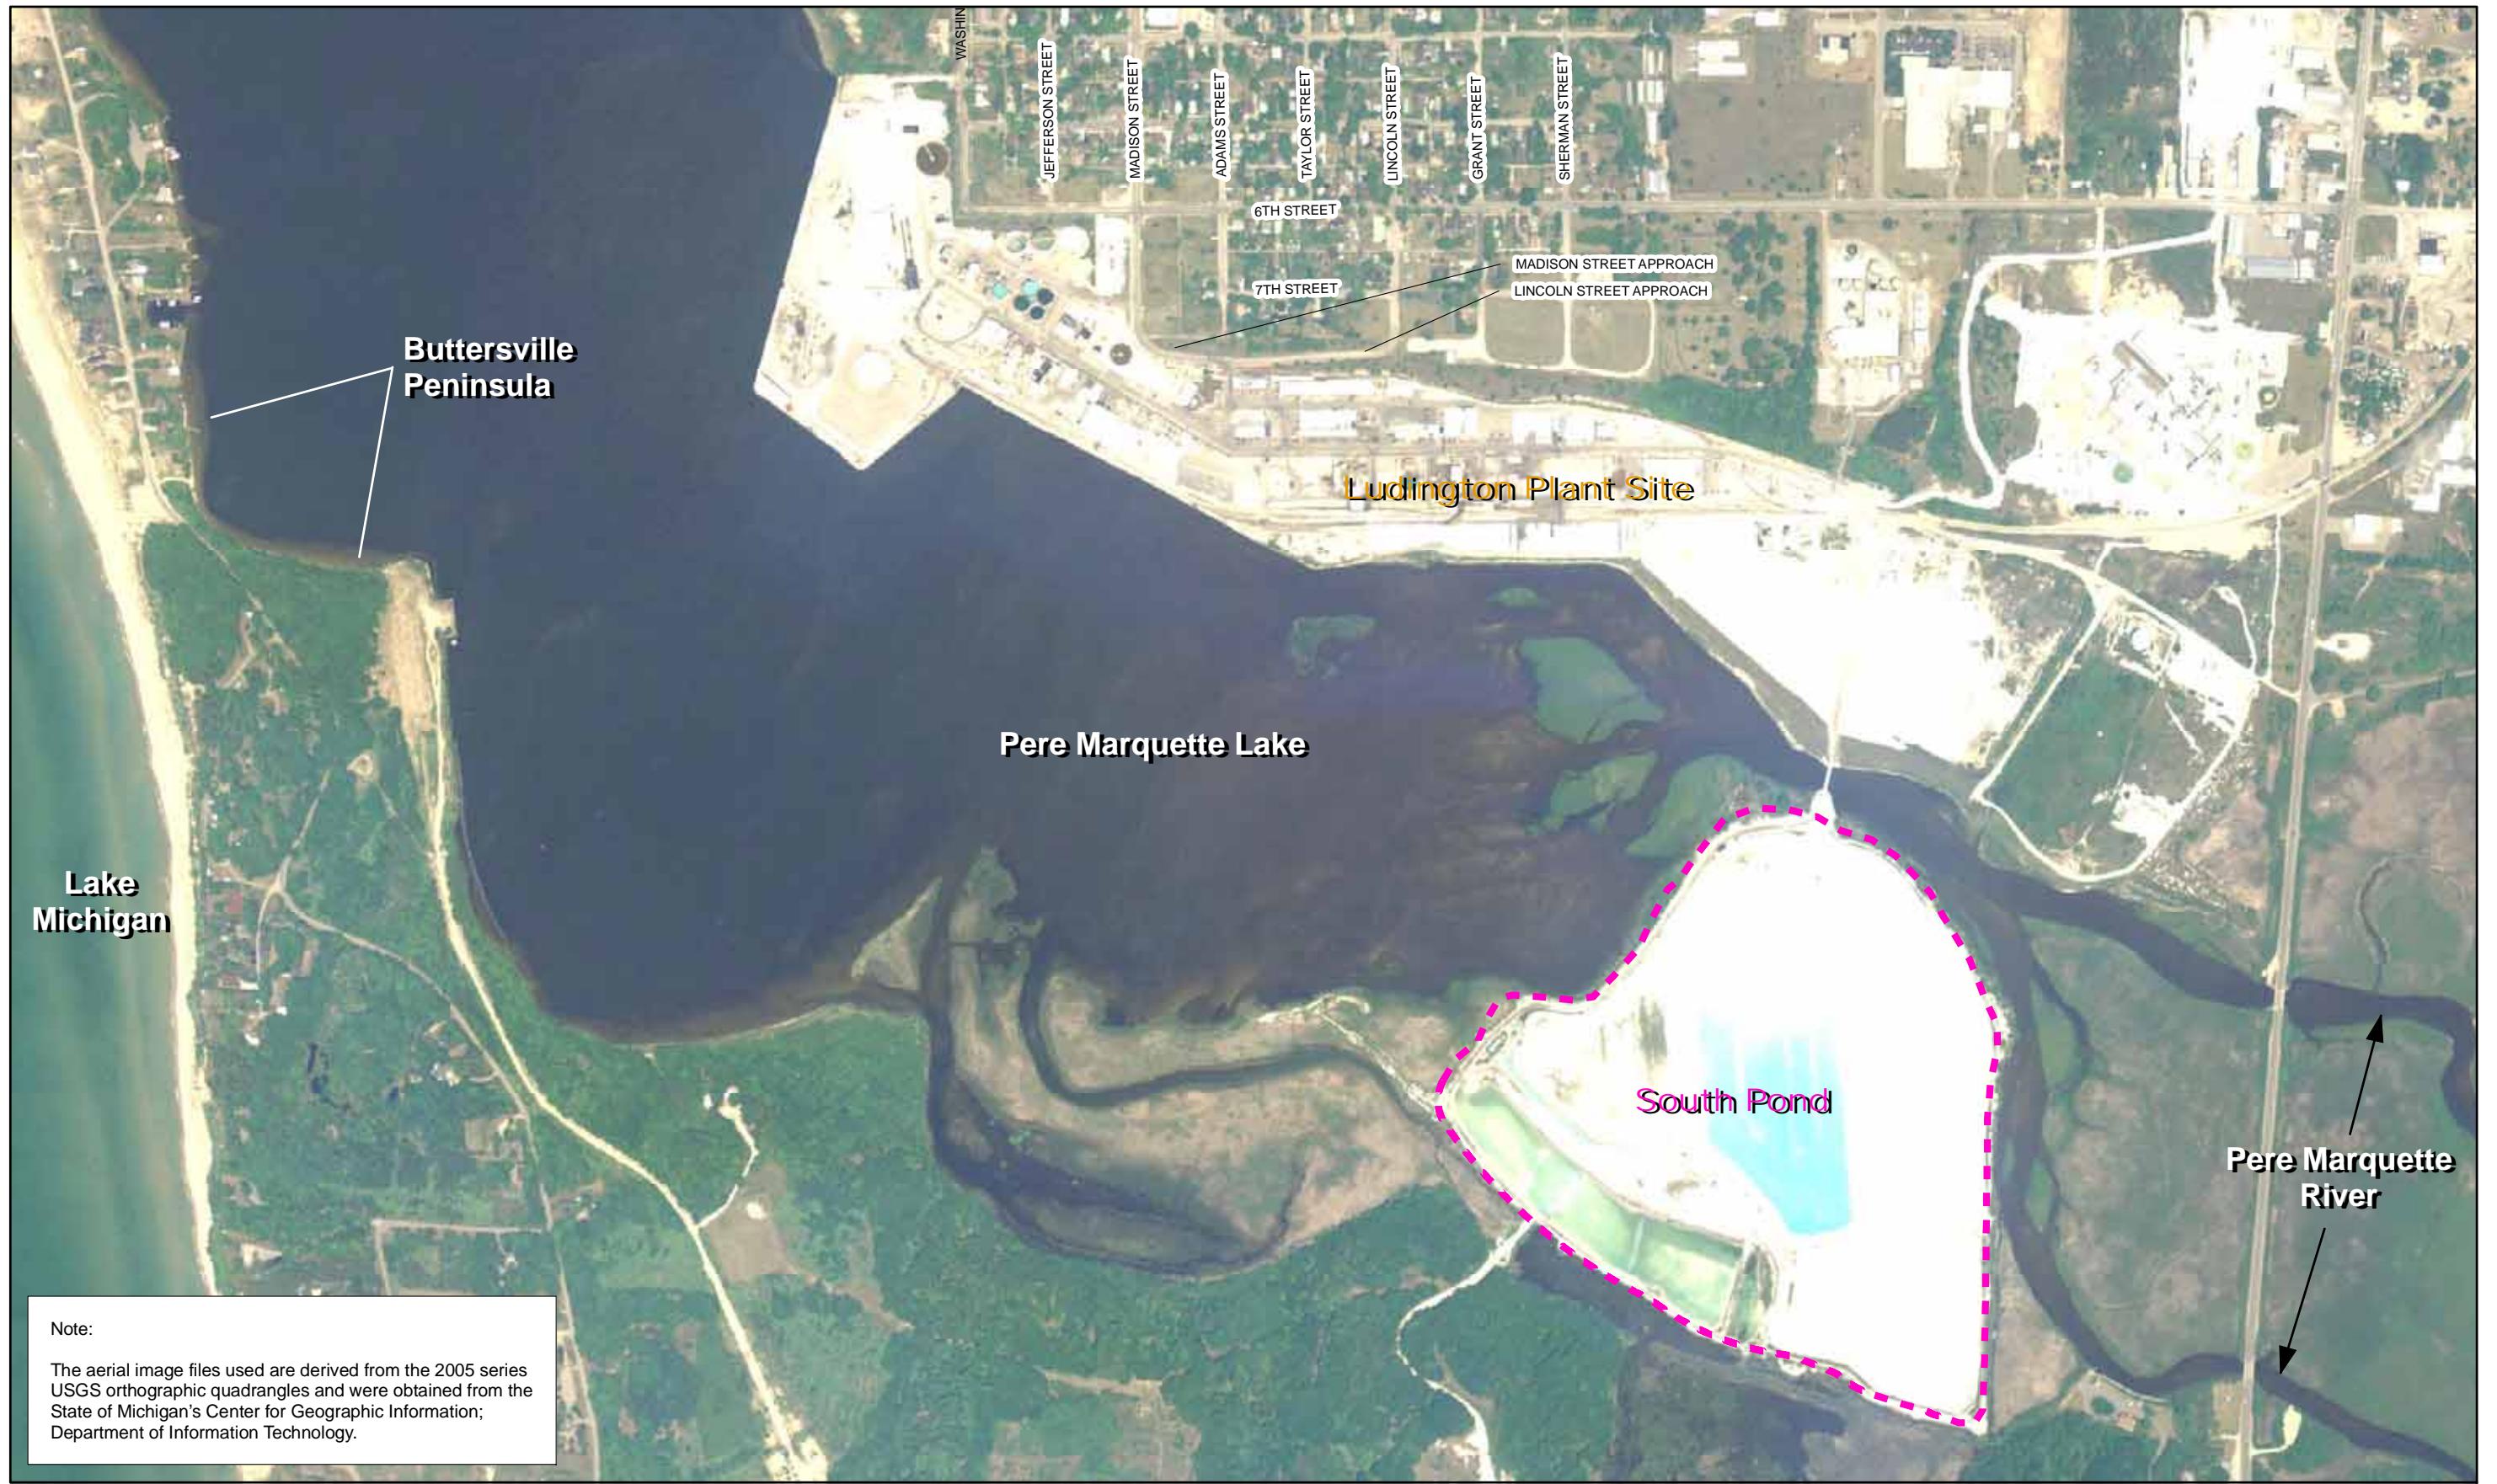
Figure 1  
Ludington Plant Site Map  
South Pond - History and Investigative Summary  
Ludington Plant Site  
The Dow Chemical Company  
Ludington, MI

The site encompasses 183 acres within an industrialized area of Ludington, Michigan, along the northeastern and eastern shores of Pere Marquette Lake (Figure 1). The site remains in operation, manufacturing various grades of calcium chloride salt and calcium chloride solution processed from brines received from Martin Marietta Magnesia Specialties, Inc.

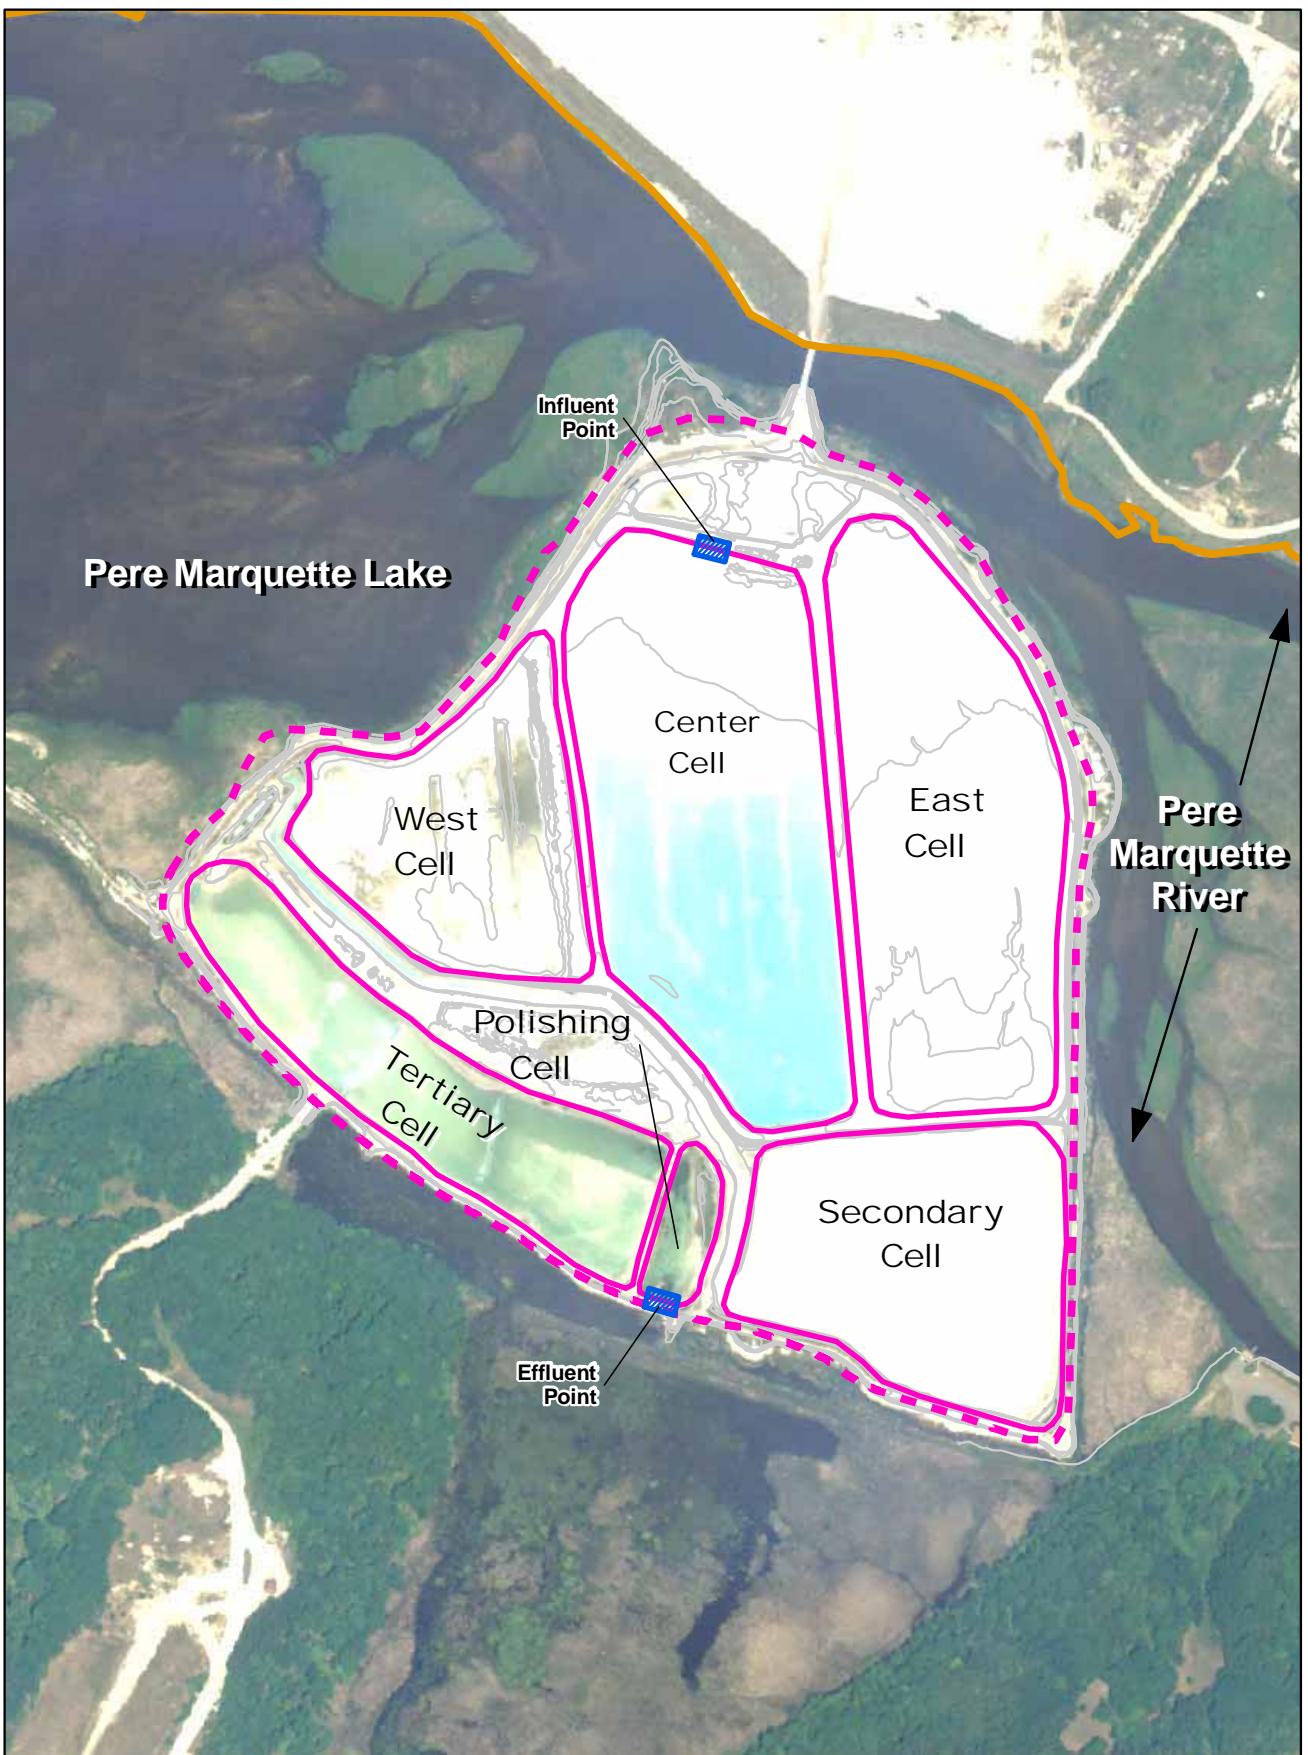
**Figure 2**  
South Pond Site Map  
South Pond - History and Investigative Summary  
Ludington Plant Site  
*The Dow Chemical Company*  
Ludington, MI

The South Pond is a series of retention cells constructed to hold post-process water delivered from the site for the primary purpose of residual solids settling (Figure 2). The original South Pond was constructed in 1962 by dredging Pere Marquette Lake to build outer dike walls. Between the late 1960s and 1980s, several additional treatment cells were installed (including the Secondary and Tertiary Cells), and dike walls were raised a number of times, using lime solids and fly ash from the interior of the pond as building material. Agricultural-grade lime was mined from the ponds beginning in 1982 and ending in 2005. Two of the three primary settling cells (East and West Cells) constructed inside the dikes are full of residual solids and are no longer in use. The West Cell of the South Pond was likely inactive by 1978 (date the cell was taken out of service is not known with certainty, but was sometime in the late 1970s to early 1980s) while the East Cell was filled and taken out of service in 1998, with the Center Cell subsequently becoming the only active cell receiving post-process water. A timeline of the South Pond construction and uses is provided on Figure 3.

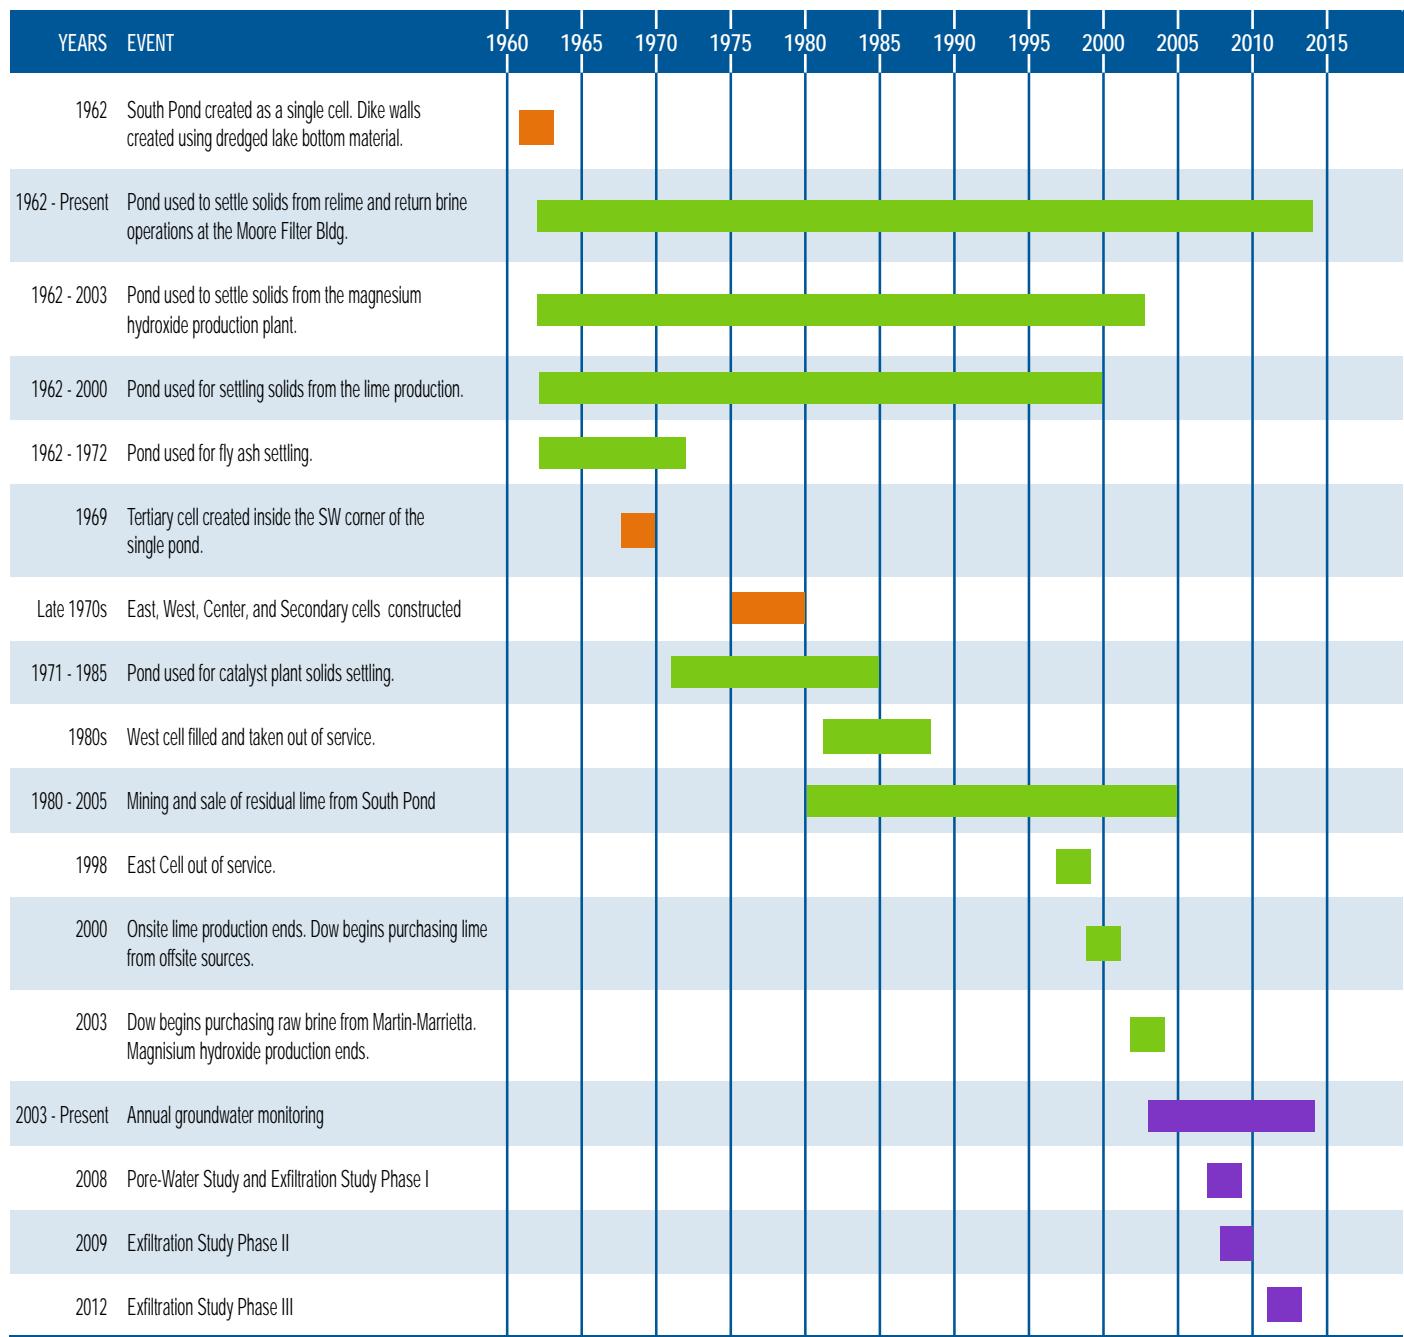
**Figure 3**

General Timeline of Industrial/Historic Operations and Environmental Investigations  
 South Pond - History and Investigative Summary  
 Ludington Plant Site  
*The Dow Chemical Company*  
*Ludington, MI*

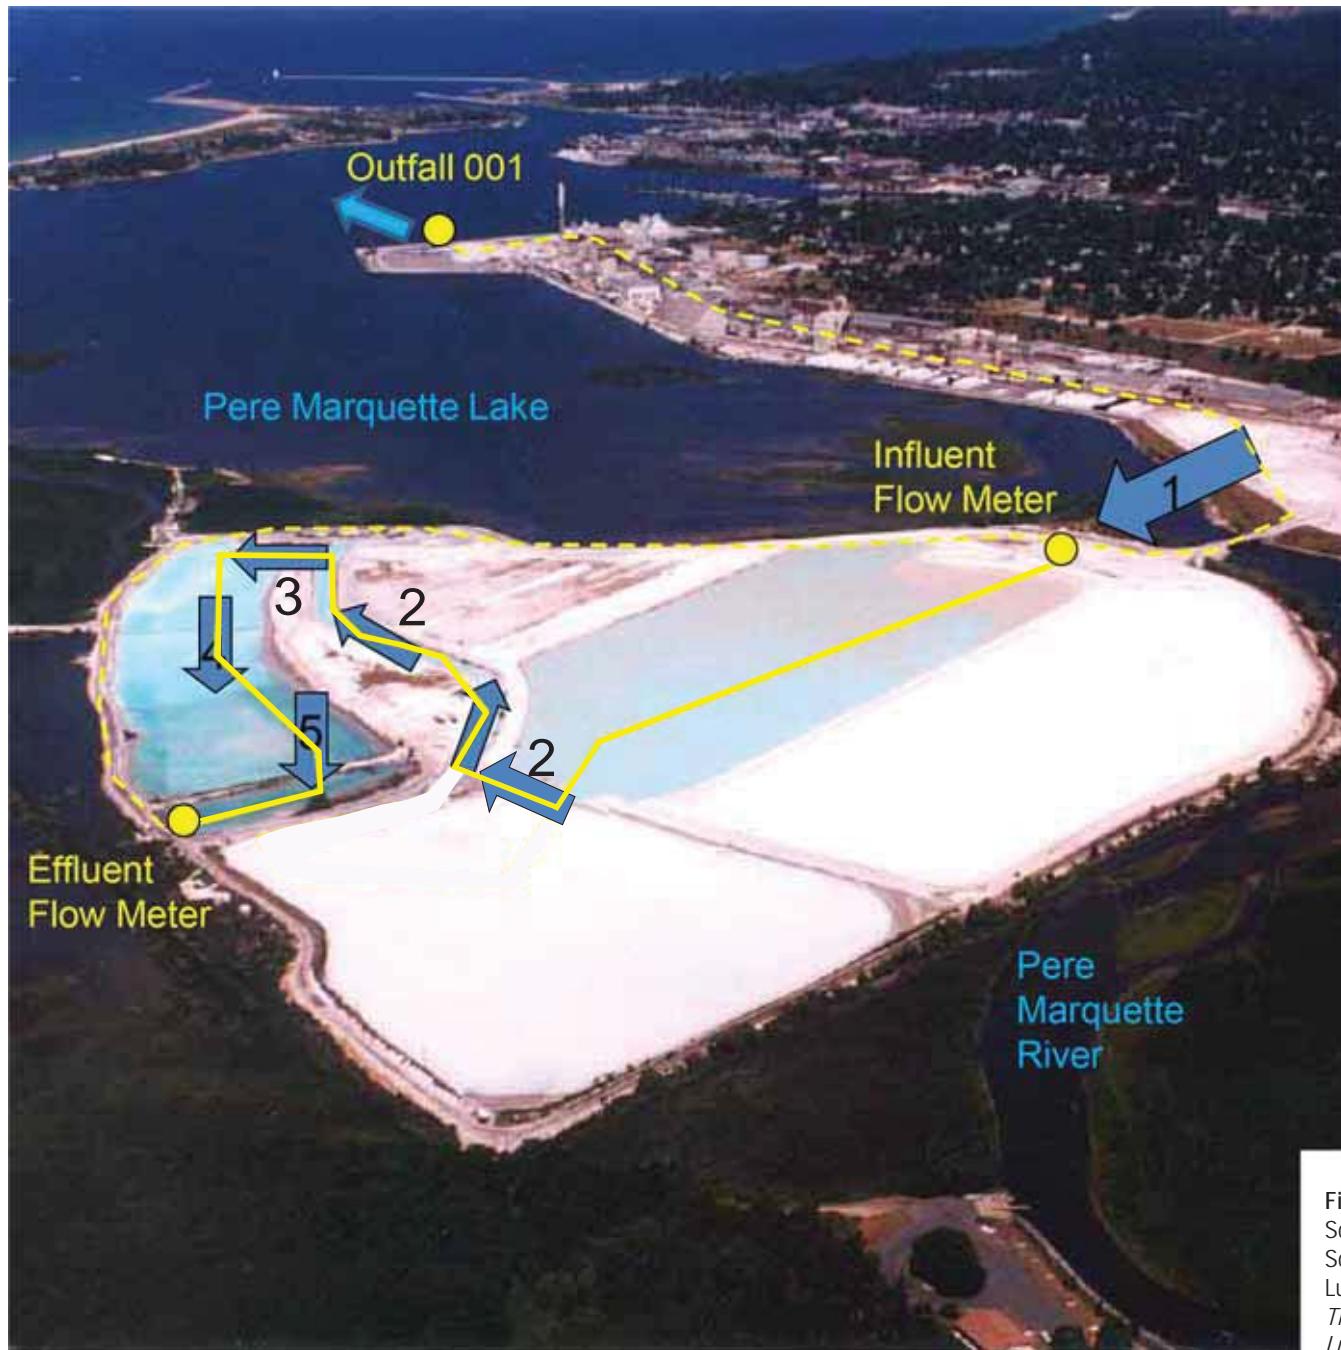
- 1 Process Water Enters Center Cell for primary settling
- 2 Travels through open channel to final settling cell
- 3 Travels through final settling cell
- 4 Travels through gate to polishing cell
- 5 Leaves polishing cell and is pumped to outfall 001

Figure 4  
South Pond - Pond Flow Pathway  
South Pond - History and Investigative Summary  
Ludington Plant Site  
*The Dow Chemical Company*  
Ludington, MI

Currently, post-process water enters the Center Cell through a pipeline that discharges at the northern end of the cell (influent) and then flows to the southern end of the Center Cell. Water from the Center Cell flows by open channel to the Tertiary Cell and then continues through to the Polishing Cell. Water in the Polishing Cell (effluent) then is pumped back to the facility where it is combined with other wastewater before being discharged to Pere Marquette Lake through Outfall 001 (regulated under the facility’s current National Pollutant Discharge Elimination System [NPDES] permit). Figure 4 provides an aerial view of the current pathway post-process water takes through the pond system. Figure 5 provides a series of historical aerial photographs that document the changes of the South Pond from preconstruction in 1951 to its 1993 status.

The dike walls were raised approximately 6 feet in 1972, using lime solids and fly ash from the pond interior. In 1975, the dike walls were widened approximately 8 to 12 feet, again using lime solids and fly ash from the pond interior. Dike walls were raised in 1980 (approximately 5 feet). Interior dike walls were constructed in the late 1970s to divide the large primary cell into four smaller cells, creating the West, Center, East, and Secondary Cells that can be seen today (Figure 4). A graphical representation of the South Pond dike construction is presented on Figure 6.

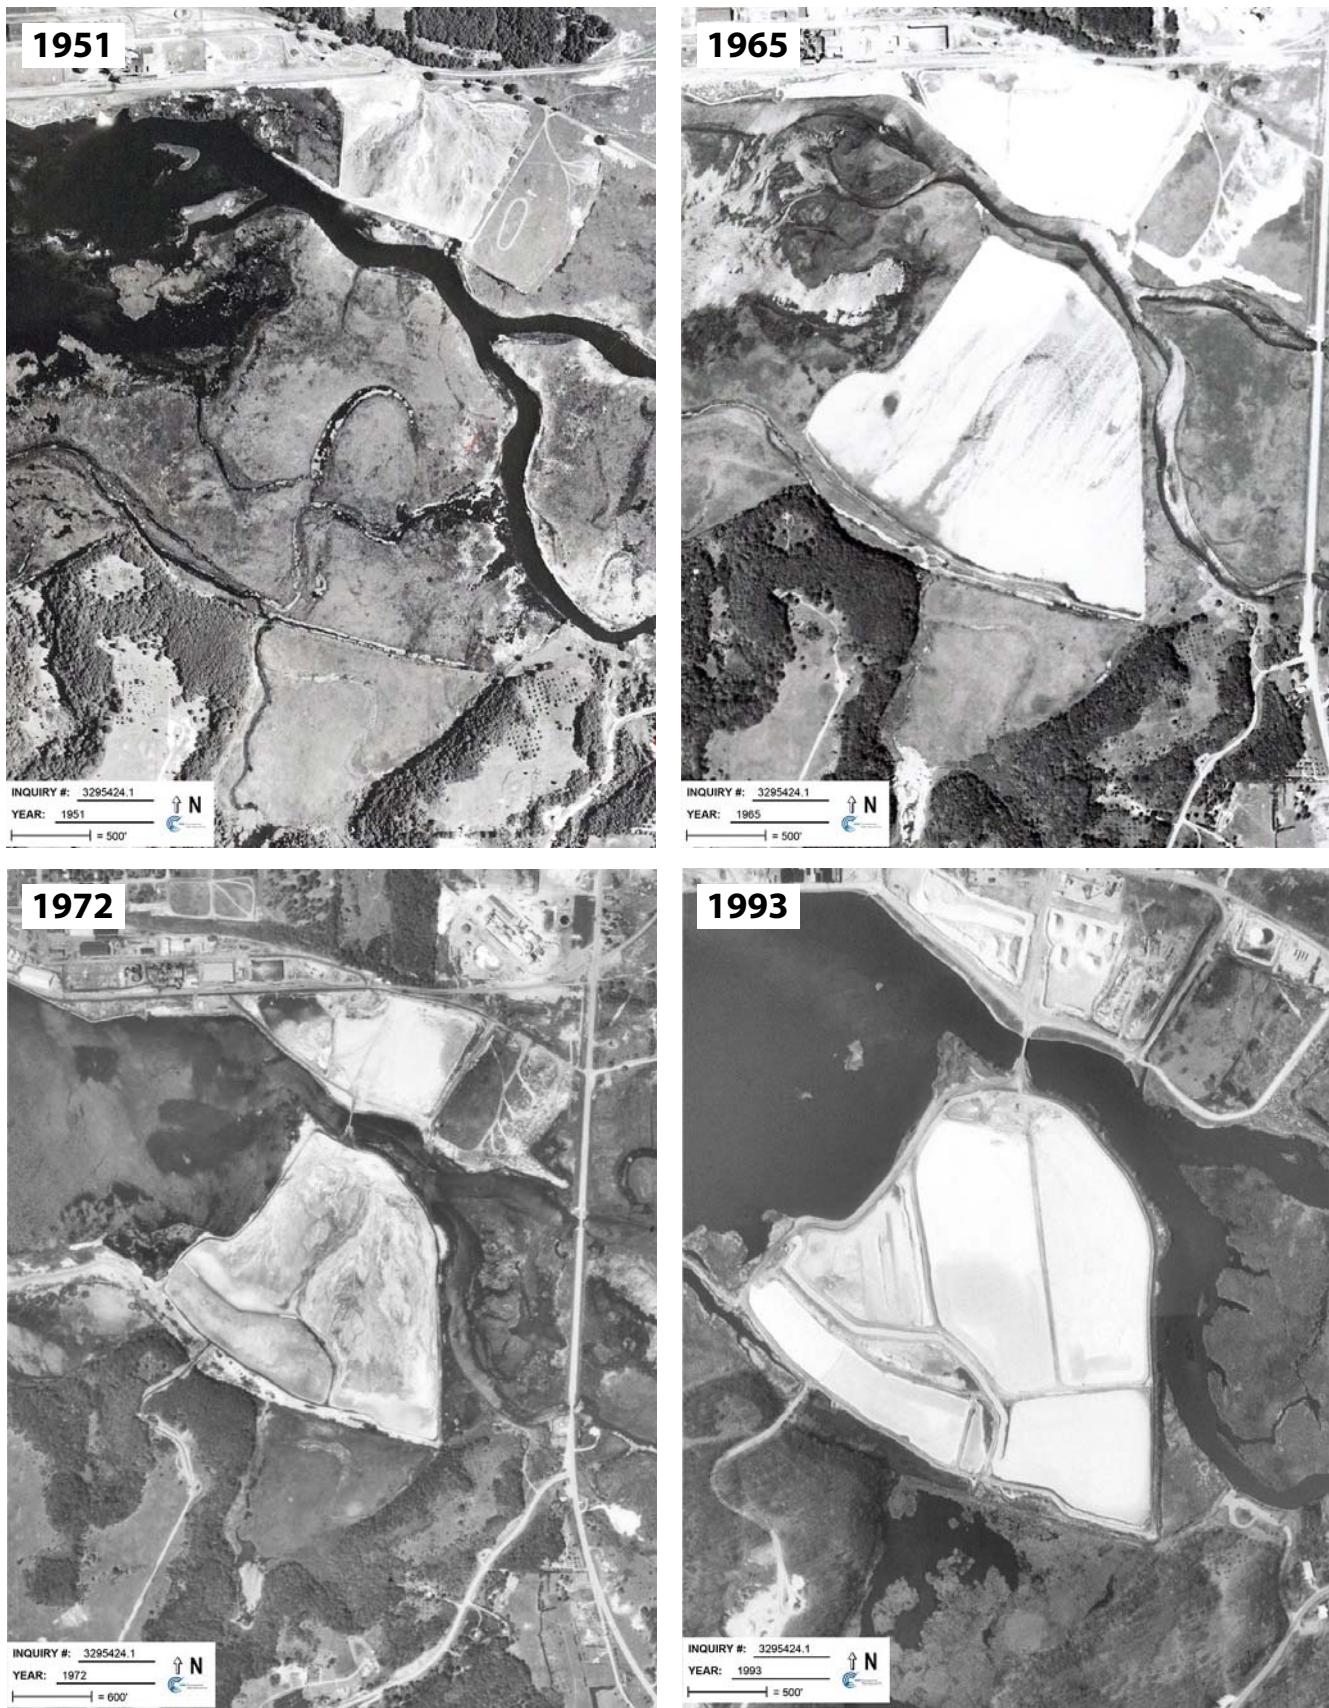
**Figure 5**  
 South Pond Historic Aerial Photos  
 South Pond - History and Investigative Summary  
 Ludington Plant Site  
*The Dow Chemical Company*  
*Ludington, MI*

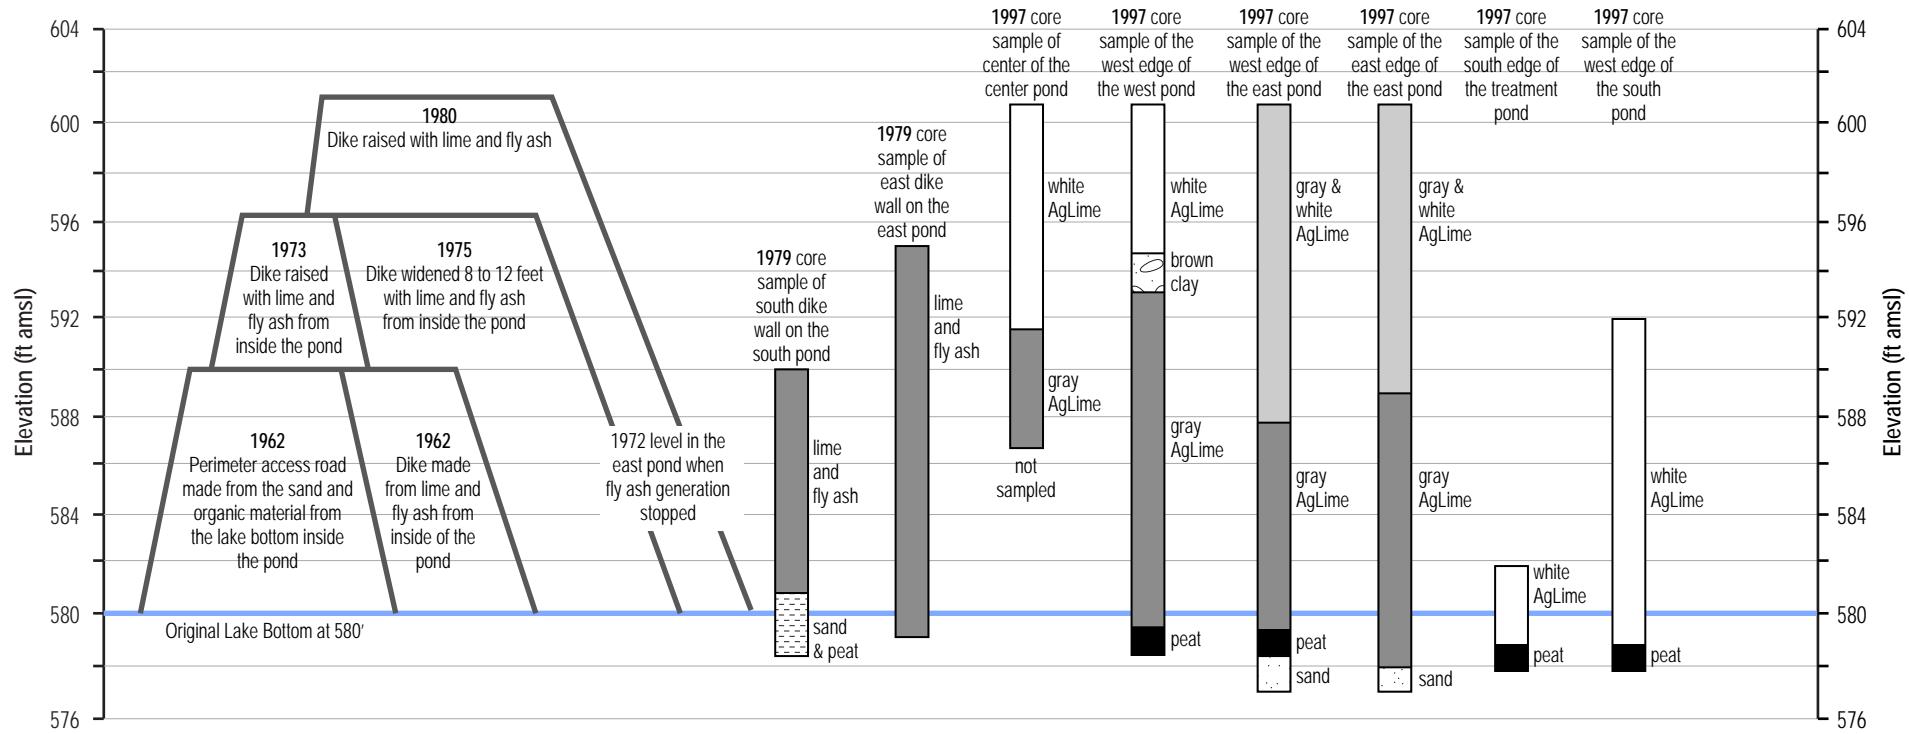
- White AgLime
- Gray & White AgLime
- Gray AgLime
- Brown Clay
- Sand
- Sand & Peat
- Peat

SOURCES: 4/23/87 STS Consultants report,  
11/18/97 West Michigan Testing report

**Figure 6**  
South Pond Dike Wall Composition and Construction History  
South Pond - History and Investigative Summary  
Ludington Plant Site  
*The Dow Chemical Company*  
Ludington, MI

In 1979 and 1997, Dow sampled several pond and dike wall cores to determine the thickness and make up of residual solids within the pond cells and surrounding dikes. The 1979 cores confirmed that the southern and eastern dike walls were primarily comprised of lime and fly ash fill. The 1997 cores, collected from the interior of the West, East, Center, Secondary, and Tertiary Cells, confirmed the lime solids are comprised of white and gray agricultural-grade lime. In addition, several of these 1997 borings penetrated into the native sand and peat beneath the pond cells. The results of the 1979 and 1997 coring activities are summarized on Figure 6.

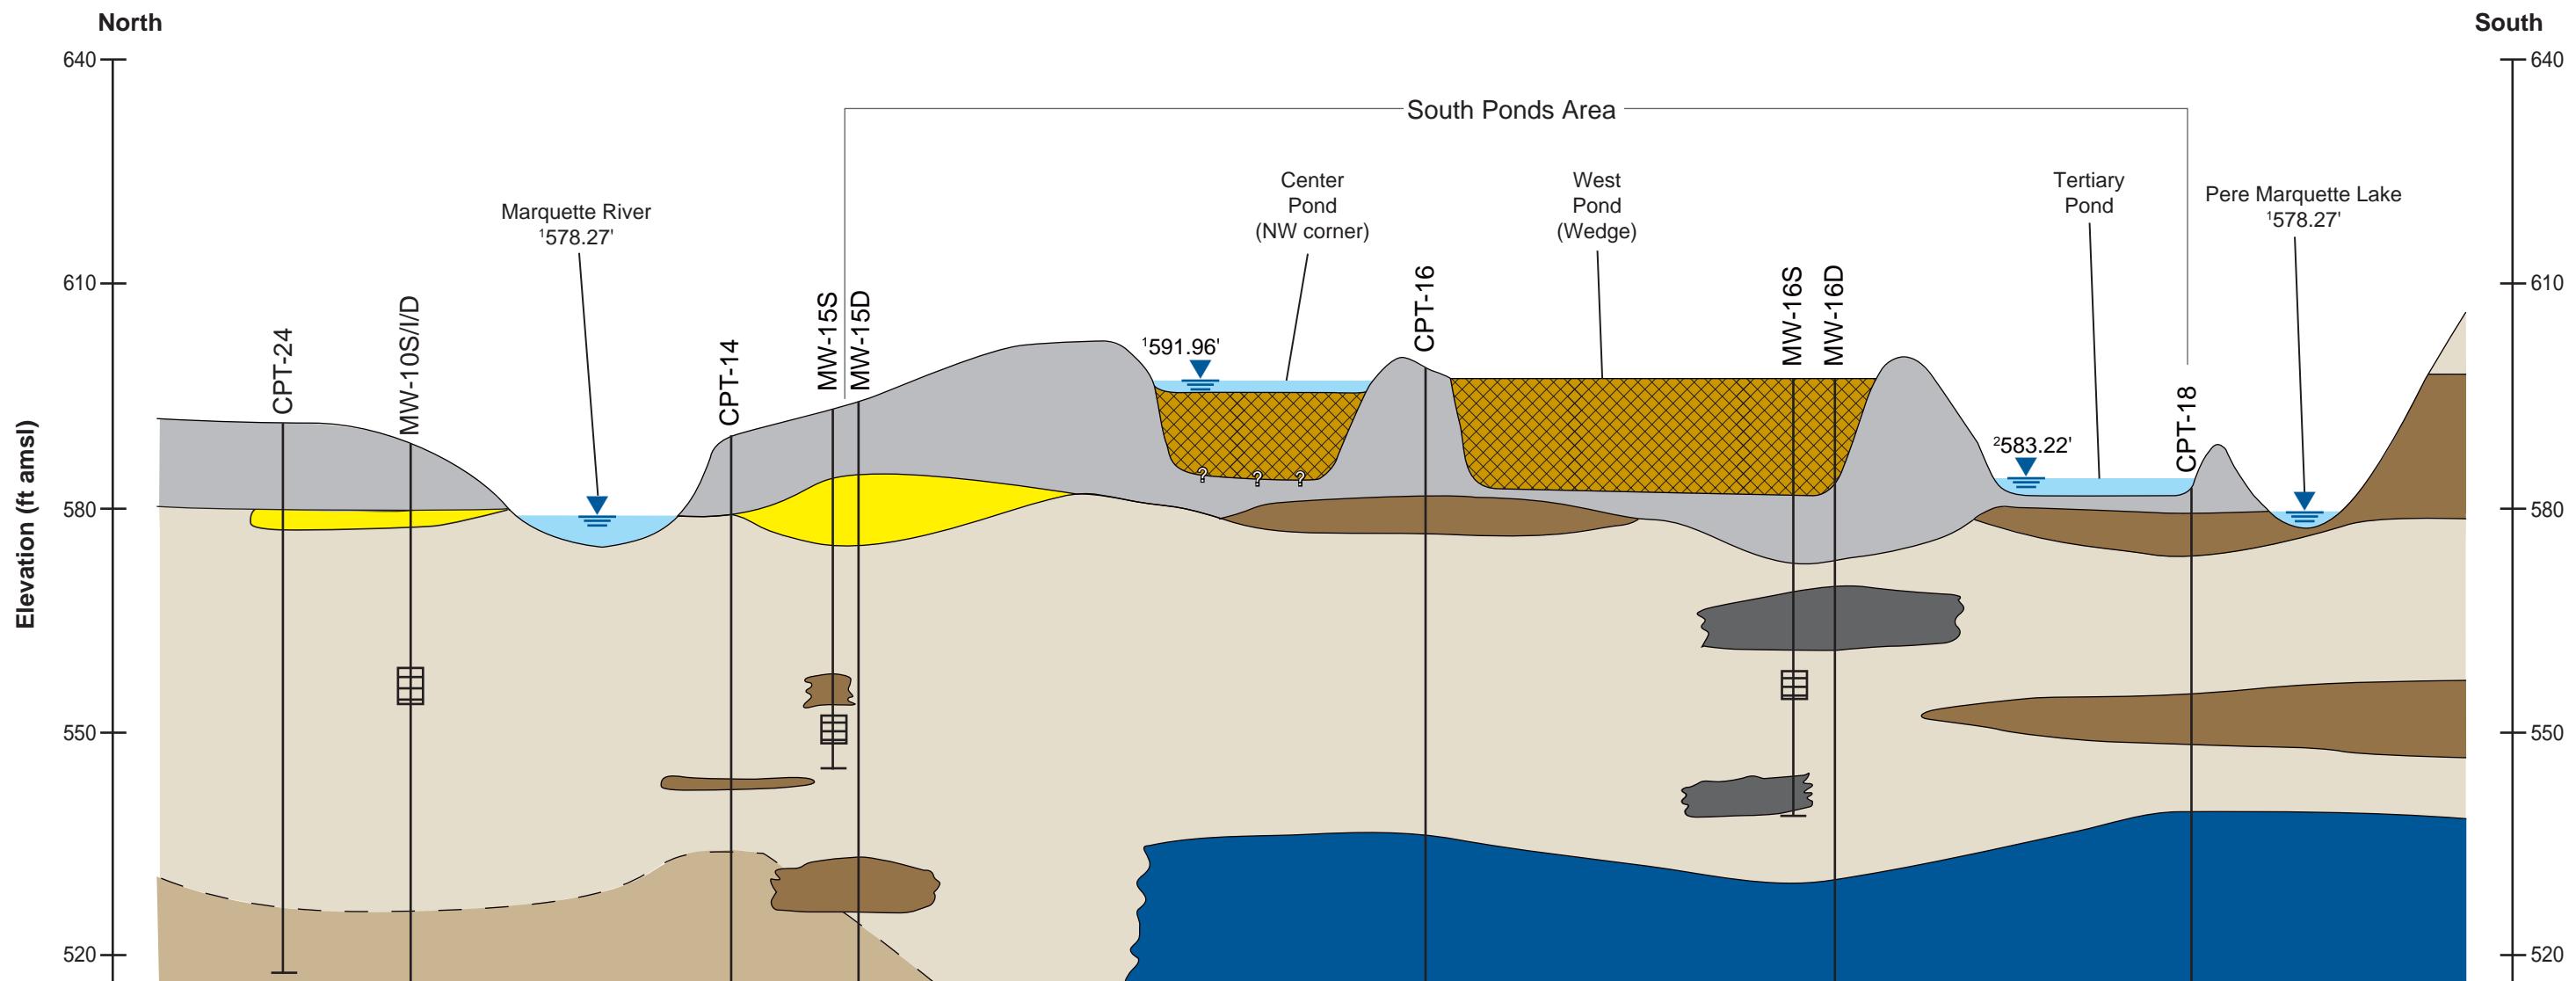
- Fill (lime solids/flyash)
- Sandy Silt
- Organics
- Clay
- Silty Sand
- Very Dense Silty Sand
- Lake Clay
- Residual Solids (lime solids/flyash)
- Geologic Boundary
- Transitional Boundary
- Soil Boring/CPT Sounding
- Well Screen
- Surface Water Elevation (feet above mean sea level)
- ?

1 Average water level for Pere Marquette Lake for April 16, 2012. CPT locations are shown for stratigraphic purposes only.

2 Water level elevation in Center and Tertiary Ponds was measured during site topographic survey performed in November 2011.

**Figure 6**  
South Pond Cross-Section  
South Pond - History and Investigative Summary  
Ludington Plant Site  
The Dow Chemical Company  
Ludington, MI

Figure 7 provides a north-south cross-sectional view of the South Pond and shows the approximate thickness of lime solids and position of the dike walls, relative to the surrounding surface water bodies. It also provides a view of the native post-glacial soils that lie beneath the pond solids.

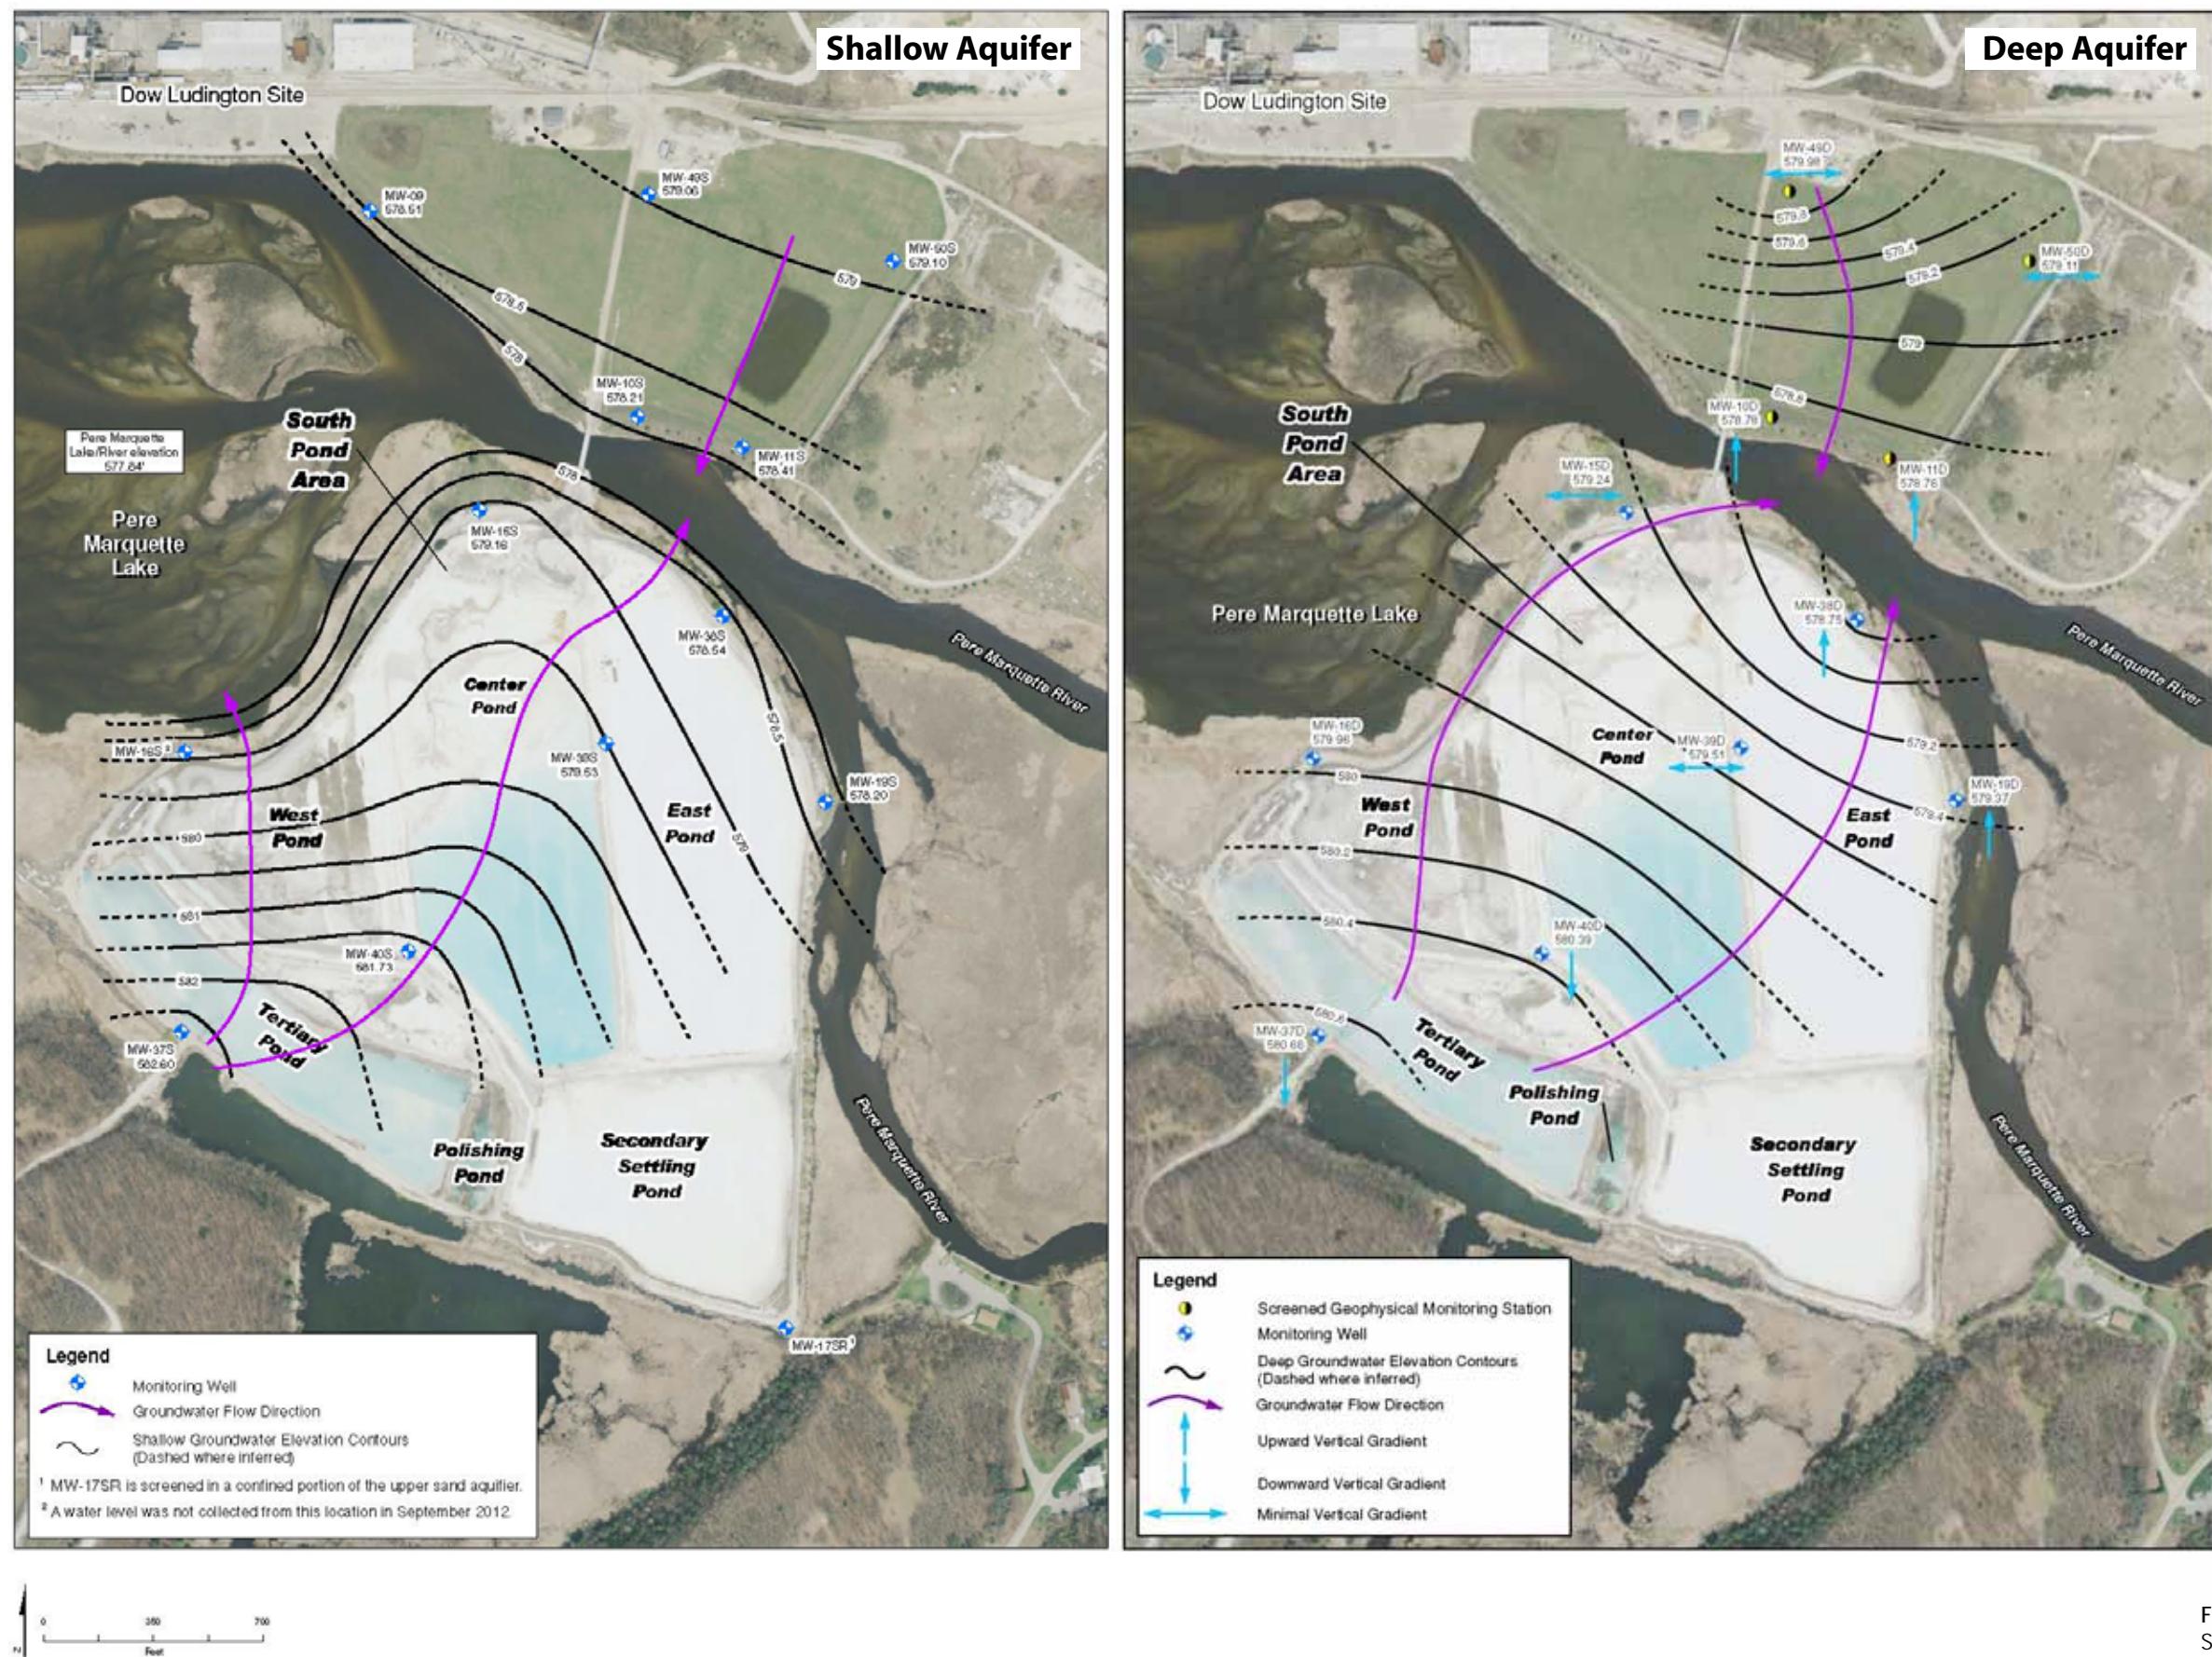
**Figure 8**  
South Pond Shallow and Deep Potentiometric Surface Maps - September 2012  
South Pond - History and Investigative Summary  
Ludington Plant Site  
The Dow Chemical Company  
Ludington, MI
